Designer Contracts

COMMON LVT FAULTS & ISSUES

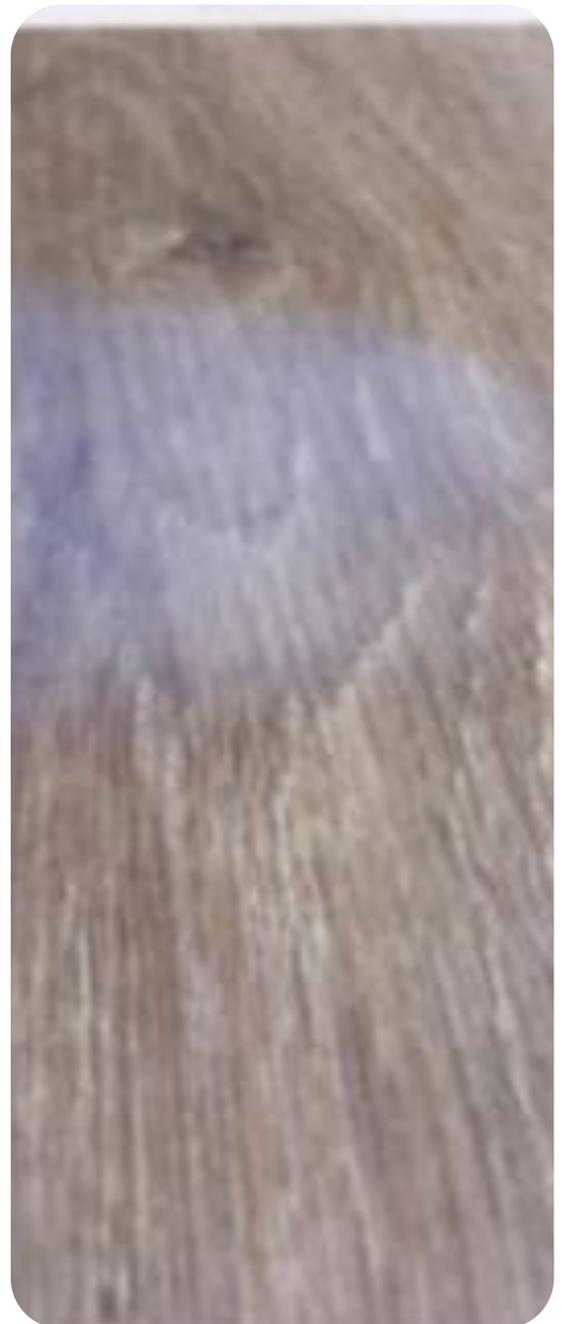
LVT Discolouration Known as “Blush” Effect- NOT a Manufacturing Fault - Local Causes Chargeable

In some situations, where water is in prolonged contact with the floorcovering surface, an opaque or milky haze can be formed within the wear-layer of the product. This is commonly called “blush” or “blushing” Contributory causes can be, for example, water trapped under a fixture or fitting, floor protection, mat or towel, e.g. bin, toilet brush holder or pet food bowl, plant pot or floor ornament.

All heterogeneous (multi-layered) floorcoverings with a Polyurethane wear-layer are susceptible to the effect when water is left in prolonged contact with the floorcovering surface. If the affected area is left to dry out, for a period of time the effect will fade and, in most cases, completely disappear.

Example below, showing an area of “blush” left from a porous terracotta plant pot. The area recovered in 48 hours.

It is recommended that the floorcovering is dried after wetting and no water is left standing on the surface. Wet items, such as towels and mats should be lifted off the surface and water should not be entrapped under items.

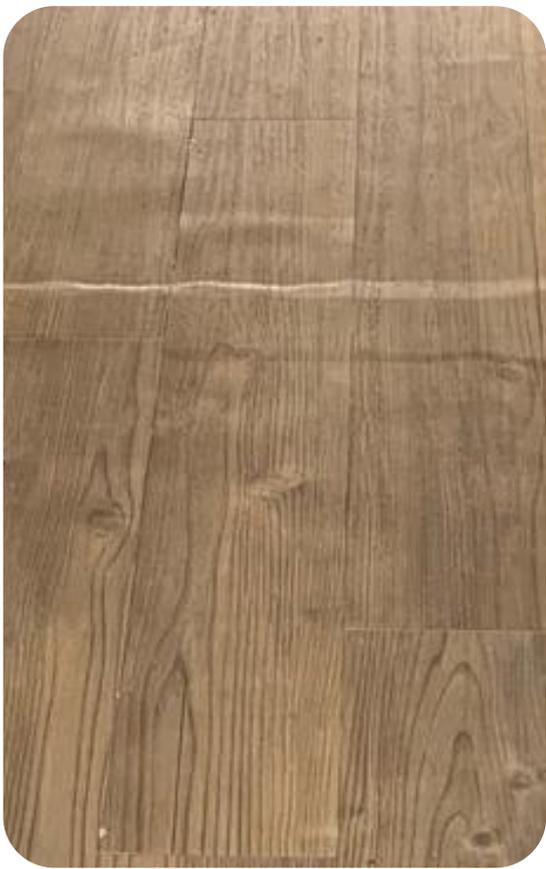
Telegraphing - NOT a Manufacturing Fault. Inspection required to confirm cause

“Telegraphing” is the term used to refer to visible swirls or patterns on the surface of resilient flooring such as LVT caused by the impression of some unevenness of the subfloor underneath it.

Telegraphing is more visible with backlighting and is accentuated when the flooring is polished. It is much less visible on floorings that have a matte finish.

Telegraphing occurs when the resilient flooring conforms to subfloor features or textures, coatings, adhesives, debris or plywood over which it is laid.

The flooring eventually conforms to the subfloor, and the topography becomes visibly distinguishable on the flooring surface.

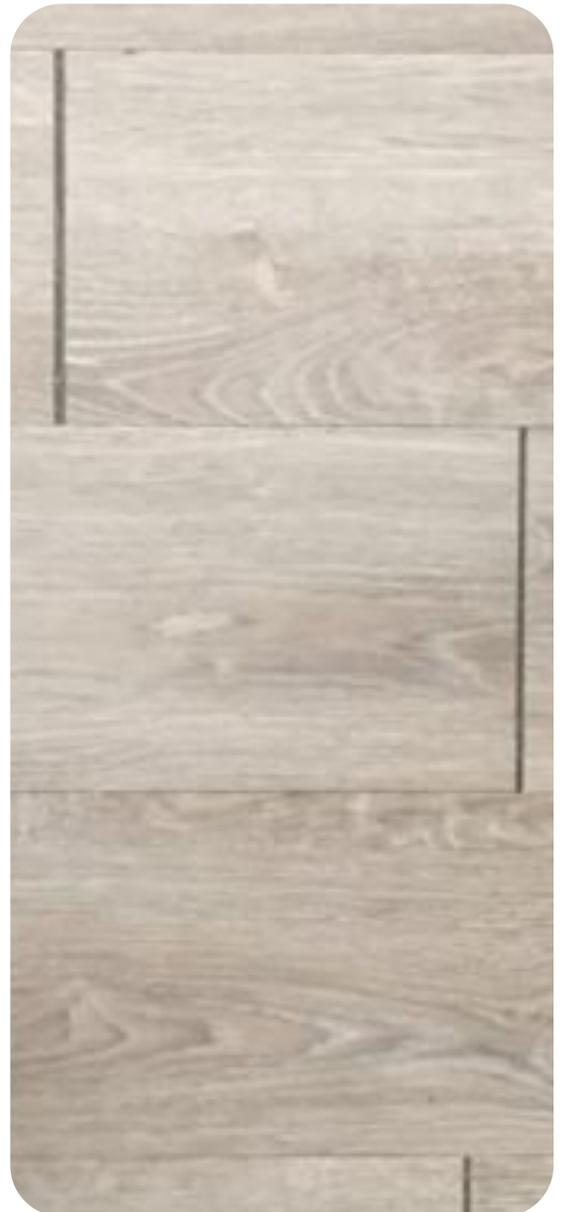
Gapping - Local Causes, Manufacturing Fault or Contractor Fitting Issue.

Gaps are created when the planks move away from their position creating space between the boards. These problems are mainly caused by decreases in temperature of the room, movement within the property and applying mastic around the perimeter too early. The composition of LVT and LVP is mostly vinyl, virgin or recycled vinyl. Vinyl expands when warm and contracts when cool. Installing LVT in new construction during the winter where they provide temporary heat can lead to issues. The LVT expands when the room is warm, and when the heat is removed, it contracts and starts to gap. Not only is the LVT affected, removing the heat also affects the adhesive. Click LVT gapping can be because of poor installation, if the click system isn't properly connected. Refer to the relevant LVT installation guidelines on the on the PIC. Hairline gapping is normal up to 3mm; however some gapping will be considered excessive, and the product may not have performed as we would expect in which case a replacement may be necessary.

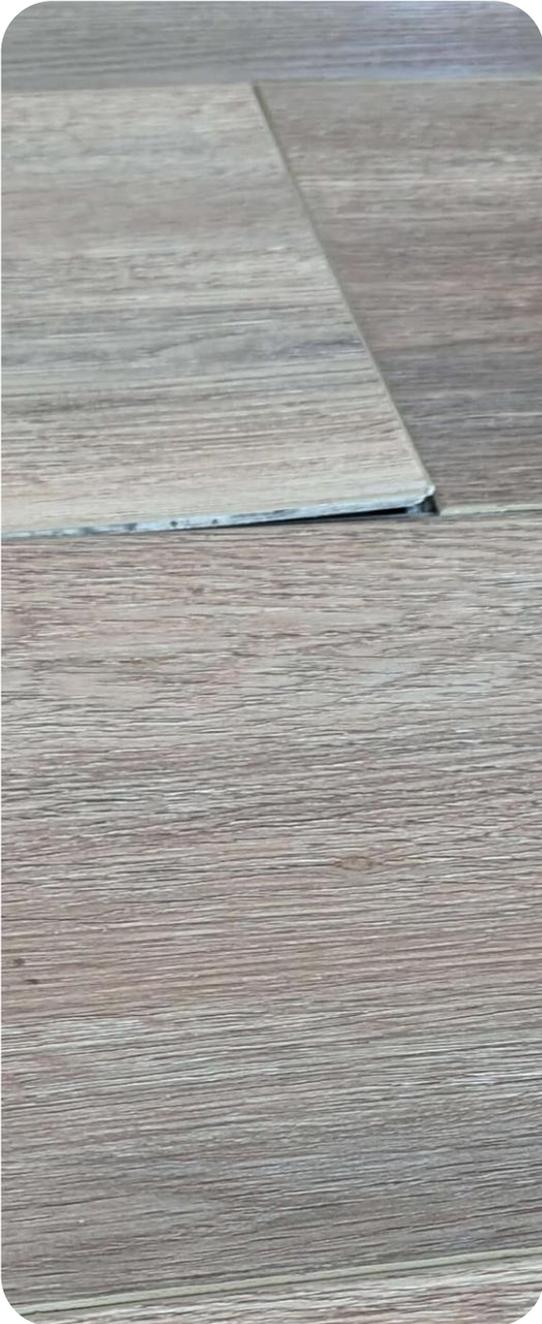
Lifting - NOT a Manufacturing Fault- Possible Local Causes. Inspection required to confirm cause

Generally caused by incorrect installation, issues with the subfloor or incorrect temperature setting of underfloor heating systems. Adhesives take 3-5 days to reach their cure. Extremes of temperature cold or hot can affect the curing process which also impacts the holding power of the adhesive. Underfloor heating systems must be switched off or down to below 15C, subfloor temperature, 48 hours prior to installation. The system should then be left off for 72 hours after installation and then recommissioned at a temperature increase of 3C to 5C per day, to the maximum operating temperature of 27C. This forms part of the installation guidelines for the majority of LVT products. Failure to follow this process can also lead to lifting. Mats, rugs, beanbags and other insulative items should also not be placed on areas of underfloor heating.

Also, the use of Anhydrite or Lignite screeds that are not subsequently treated and prepared properly will lead to the surface layer of the subfloor breaking up and then causing the tiles to lift.

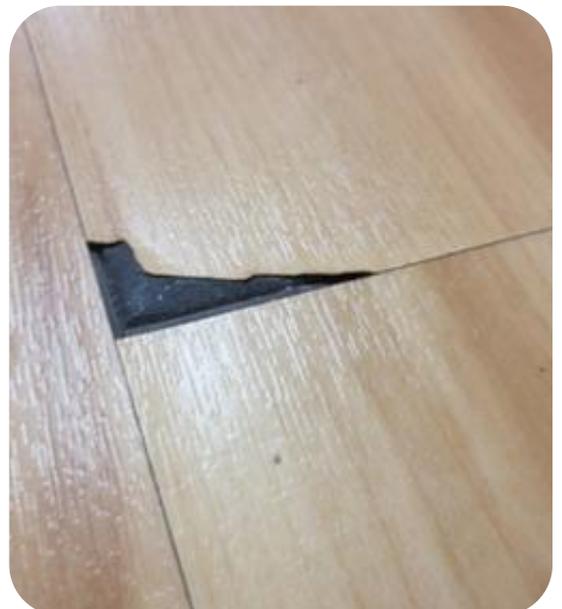
Chipping & Scratches - NOT a Manufacturing Fault- Local Causes or Contractor Fitting Issue

These floors are built up of several layers and it is possible on the click versions of LVT for the design layer to be chipped when it is struck by a falling object, during installation i.e. when tapping blocks/mallets make contact with the flooring causing dents or chips. Vacuuming with the beater bar attachment or careless handling of the flooring before it's installed can also lead to scratches.

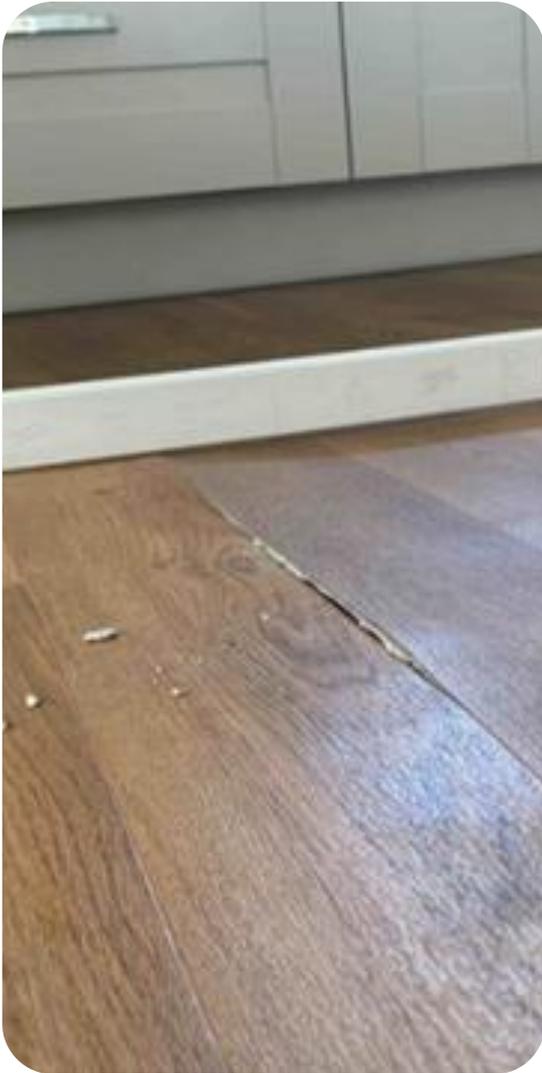
Blown Latex Due to Laitance- NOT a Manufacturing Fault- Possible Local Causes Inspection required to confirm

Laitance plays an important part in flooring installation failures, by forming a weak layer on the surface of the screed. Laitance forms on all screeds to varying degrees, and the action required will depend on the screed type. This laitance layer prevents a bond forming between the screed and substrate and needs to be removed. Causes for laitance are mainly due to excess water during curing of subfloor, which causes cement and fine aggregates to rise to the surface. Rain damage during install, over trowelling and contaminants in subfloors made of calcium sulphate or lignite, which can rise to the surface and form a crumbly crust. In many cases where there is laitance present it must be removed before any resilient floor covering is fitted. Failure to communicate the type of subfloor could lead to the incorrect products or procedures being implemented.

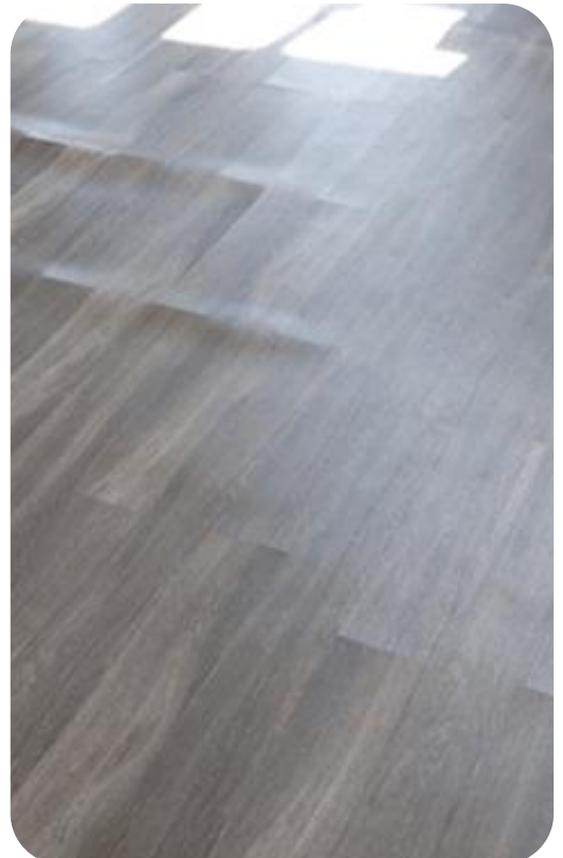
Peaking - NOT a Manufacturing Fault- Possible Local Causes. Inspection required to confirm cause

This condition occurs when the tiles/planks push up against each other at the joints, creating unlevel high points. This defect is common where the boards were not installed with sufficient space to expand around the walls. Another cause can be when doorway or perimeter moldings are fixed to the floor by nails, screws or mastic, which prevents natural expansion. Without the proper expansion joint, there can be a pressure build up, causing the flooring to peak. A good quality, Low Modulus Neutral (LMN) silicone is recommended as it is low shrinkage and has good compression and elasticity. Using the incorrect mastic or too much mastic can lead to mastic grab.

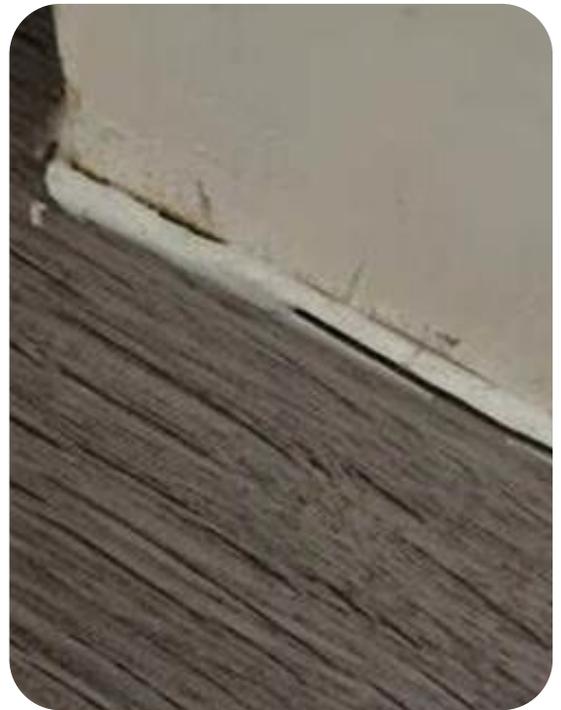
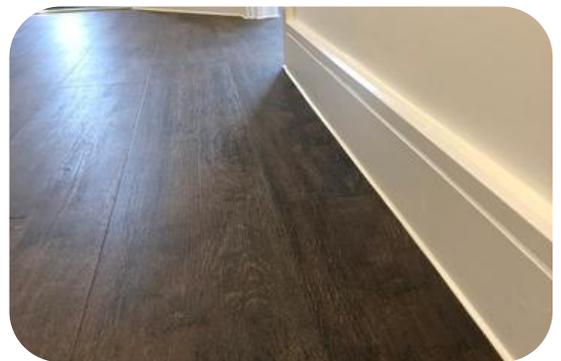
Mastic/ Silicone Grab- NOT a Manufacturing Fault. Possible Local Causes. Inspection required to confirm cause

There are strict guidelines within the installation of LVT regarding perimeter sealing. Most manufacturers of LVT recommend perimeter sealing with a suitable silicone sealant in bathrooms and WCs. Perimeter sealing other areas is not a technical requirement. A good quality, Low Modulus Neutral (LMN) silicone is recommended for this purpose as it is low shrinkage and has good compression and elasticity. Acetoxy silicones (acetic/vinegar smell) should be avoided as these may shrink and cure very hard.

It is very important that silicone sealant is not applied for at least 72 hours after installation to allow the adhesive to fully cure. If it is applied before this time there is a strong likelihood that the silicone will shrink back, lift or pull the perimeter panels causing gapping in the LVT, and a split in the mastic can be seen around the perimeter.

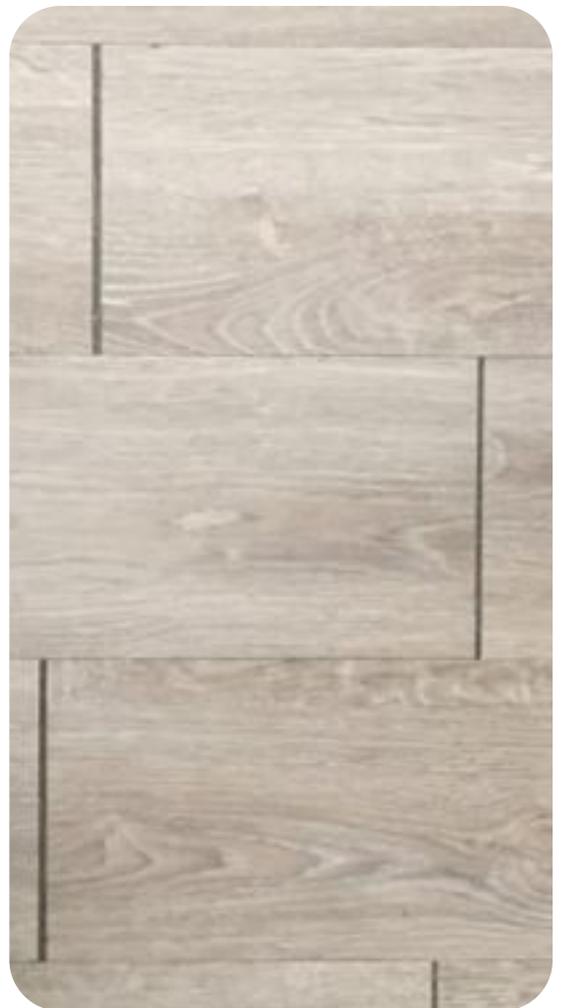
Gapping - Local Causes, Manufacturing Fault or Contractor Fitting Issue

Gaps are created when the planks move away from their position creating space between the boards. These problems are mainly caused by decreases in temperature of the room, movement within the property and applying mastic around the perimeter too early. The composition of LVT and LVP is mostly vinyl, virgin or recycled vinyl. Vinyl expands when warm and contracts when cool. Installing LVT in new construction during the winter where they provide temporary heat can lead to issues. The LVT expands when the room is warm, and when the heat is removed, it contracts and starts to gap. Not only is the LVT affected, removing the heat also affects the adhesive. Click LVT gapping can be because of poor installation, if the click system isn't properly connected. Refer to the relevant LVT installation guidelines on the on the PIC.

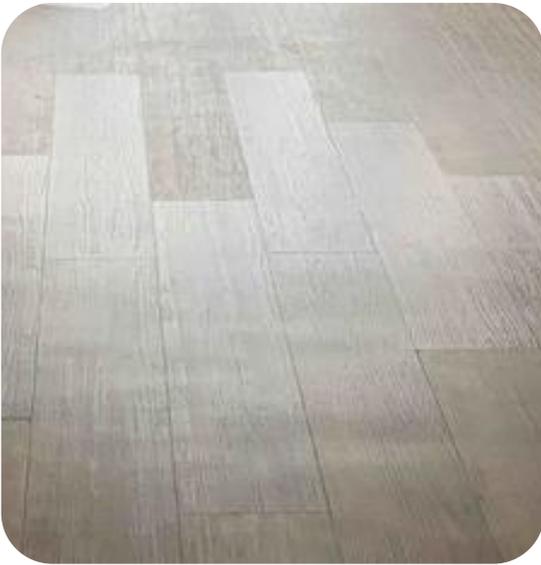
Batch Matching - NOT Generally Considered a Manufacturing Fault. Chargeable Replacement. Manufacturer May Offer Support as a Goodwill Gesture

All pack products are manufactured in batches, and therefore there can be a difference between batches manufactured at different times. It is important to understand that partial replacements are not always possible, some products are more forgiving than others.

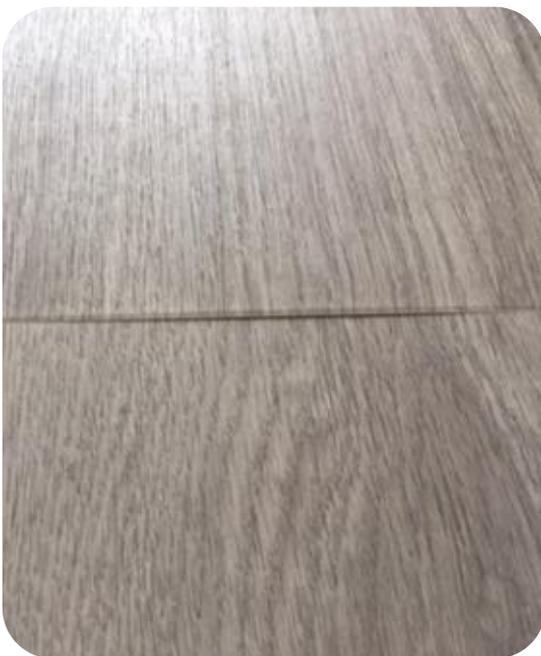
Header Joint Failure/Damage - Manufacturing Fault or Contractor Fitting Issue

The end joints could be damaged in the production process. This will be visible before installation and may be noticed during installation if the tiles do not fit together. This should be reported immediately. You should not attempt to use any tiles that have damaged end joints. The problem may or may not extend to the other tiles within the pack. The end joints can also become damaged if the product is not handled and installed properly.
